Picture 1 – Allendale Farm, 2357 Jersey Street, Pantton, VT – 09/19/13  
Concrete barnyard outside the main barn.

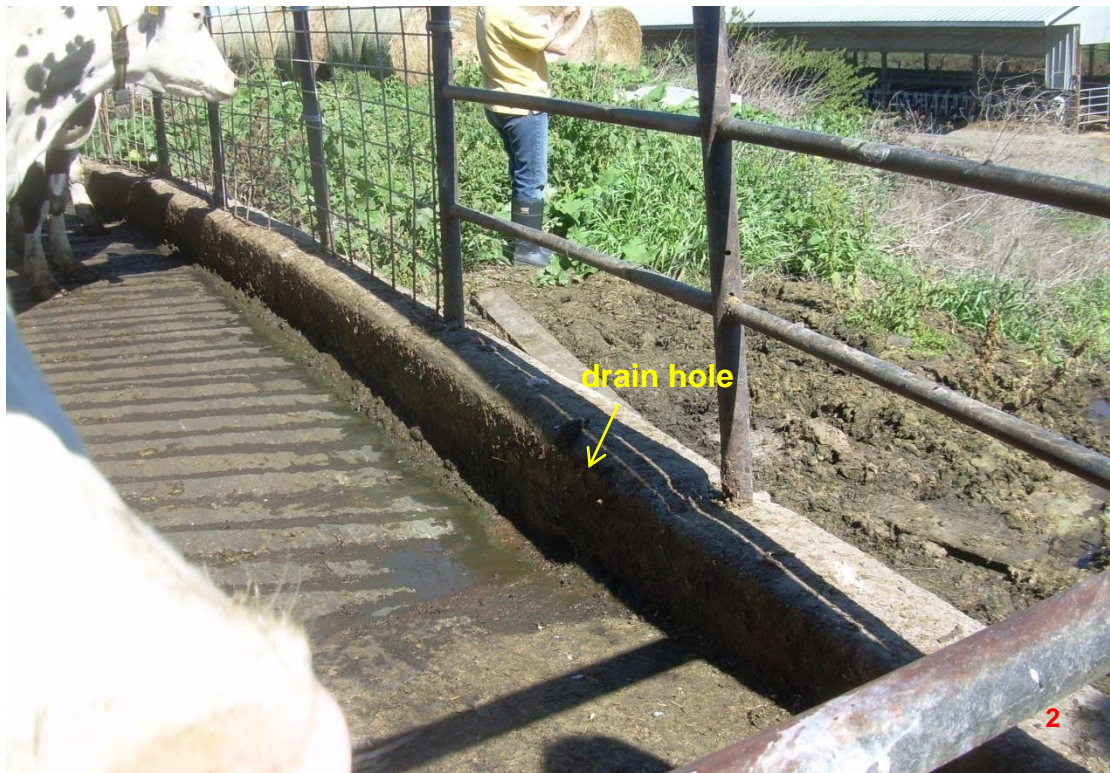
Picture 2 – Allendale Farm, 2357 Jersey Street, Pantton, VT – 09/19/13  
Drain hole in the concrete curb at the southern end of the barnyard.

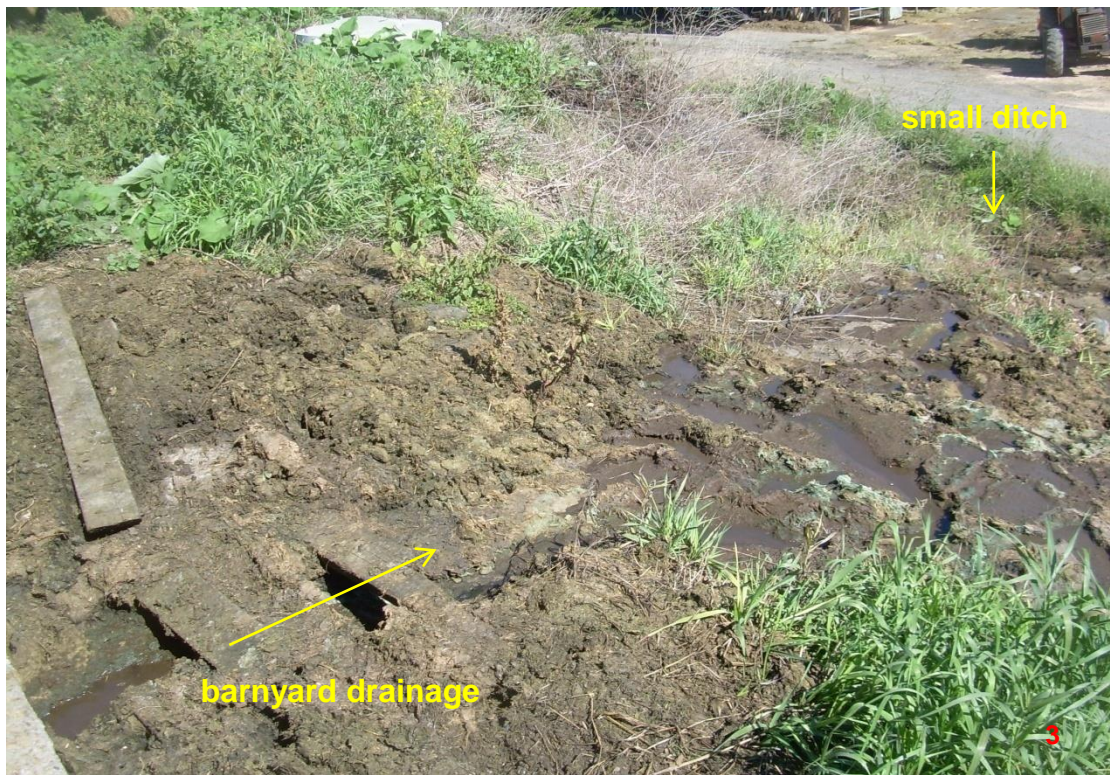
Picture 3 – Allendale Farm, 2357 Jersey Street, Pantton, VT – 09/19/13  
Barnyard runoff flows downhill into a small drainage ditch.

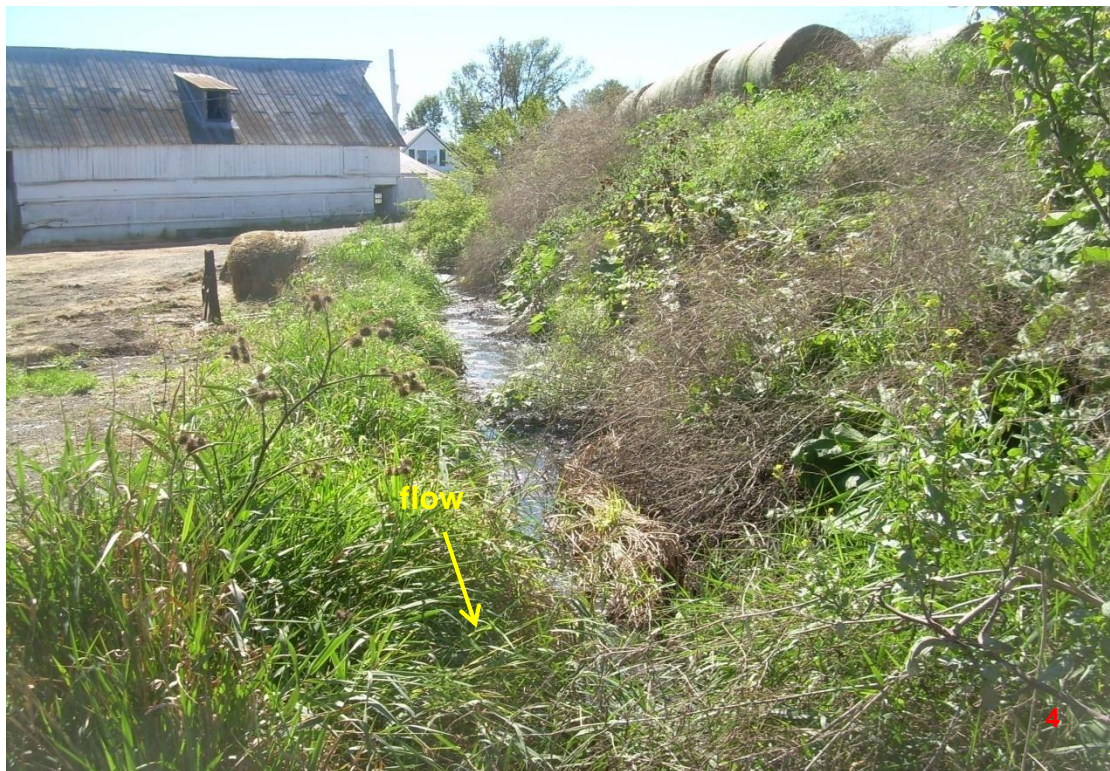
Picture 4 – Allendale Farm, 2357 Jersey Street, Pantton, VT – 09/19/13  
Small drainage ditch that receives runoff from the concrete barnyard.

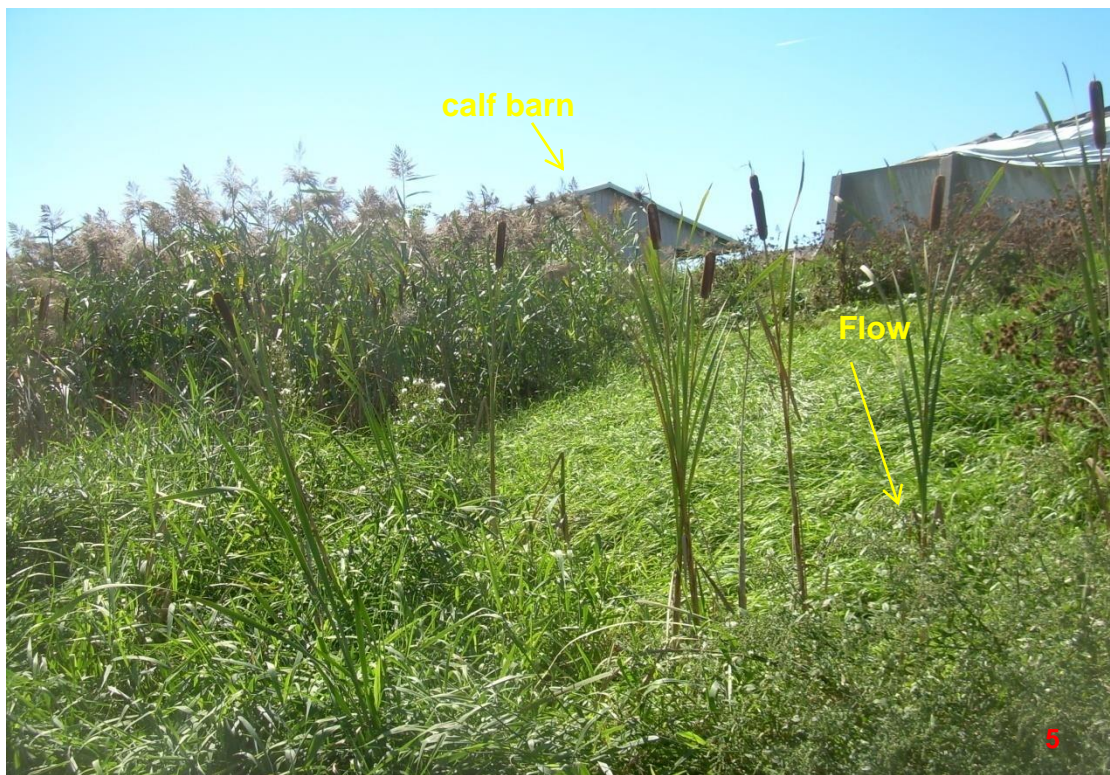
Picture 5 – Allendale Farm, 2357 Jersey Street, Pantton, VT – 09/19/13  
Vegetated swale that receives runoff from the small ditch described in pictures #3-4.

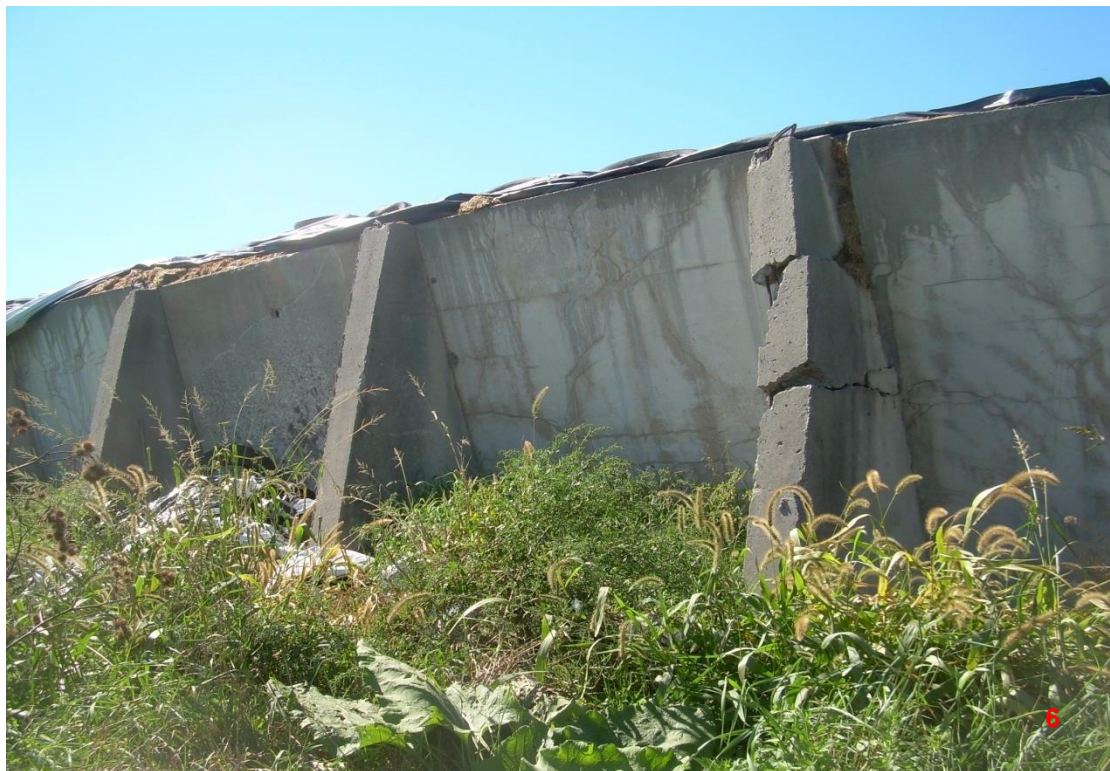
Picture 6 – Allendale Farm, 2357 Jersey Street, Pantton, VT – 09/19/13  
Broken concrete, leaks from the large silage bunker.

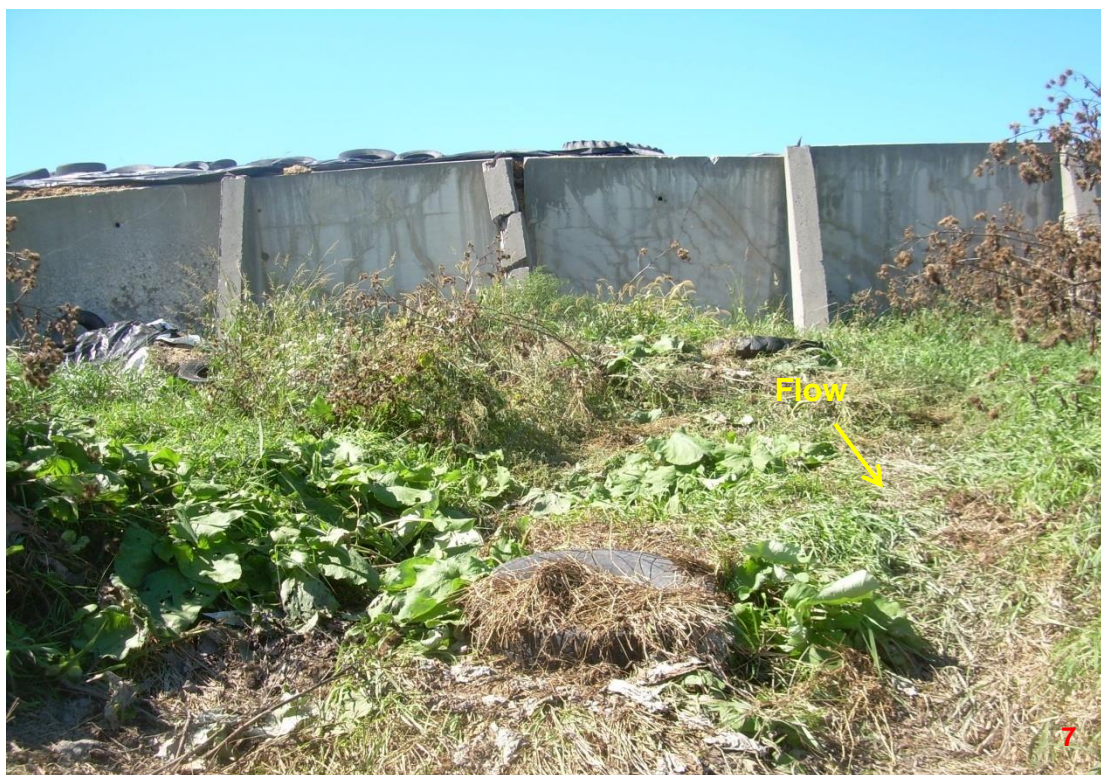
Picture 7– Allendale Farm, 2357 Jersey Street, Pantton, VT – 09/19/13  
Broken concrete, leaks from the large silage bunker.

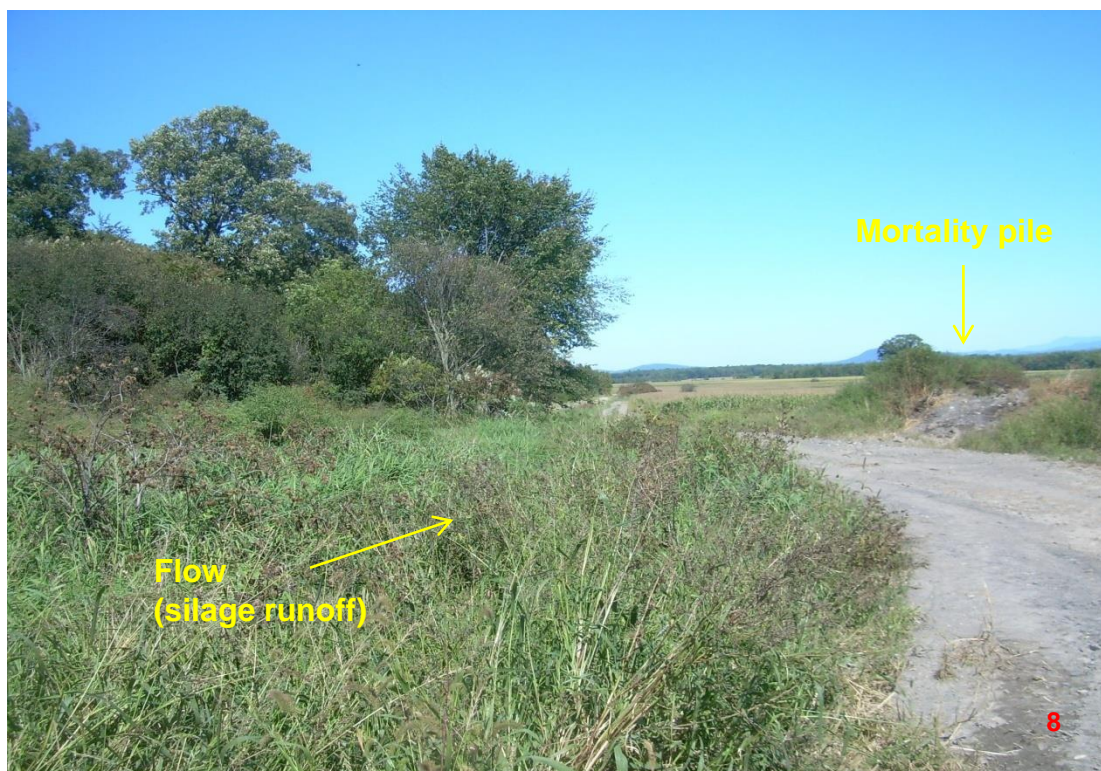
Picture 8 – Allendale Farm, 2357 Jersey Street, Pantton, VT – 09/19/13  
Roadside drainage ditch #2 on the west side of the dirt road, which receives silage runoff.

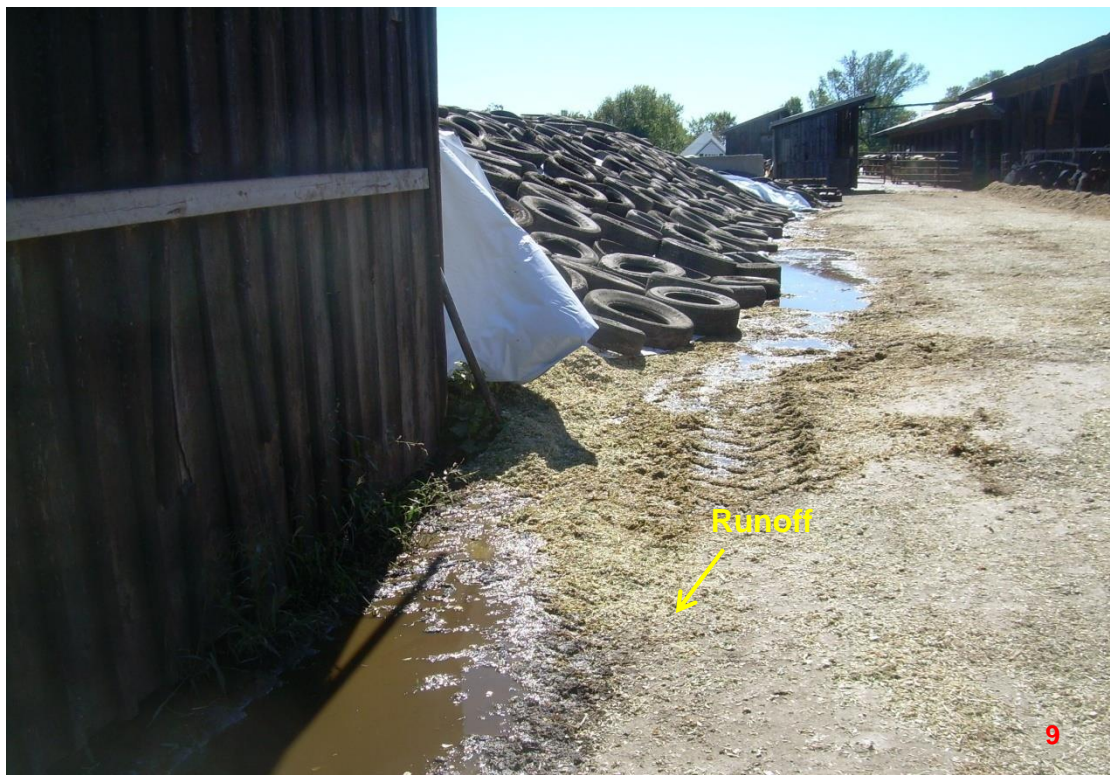
Picture 9 – Allendale Farm, 2357 Jersey Street, Pantton, VT – 09/19/13  
Runoff/leachate from the small silage pile across from the main barn.

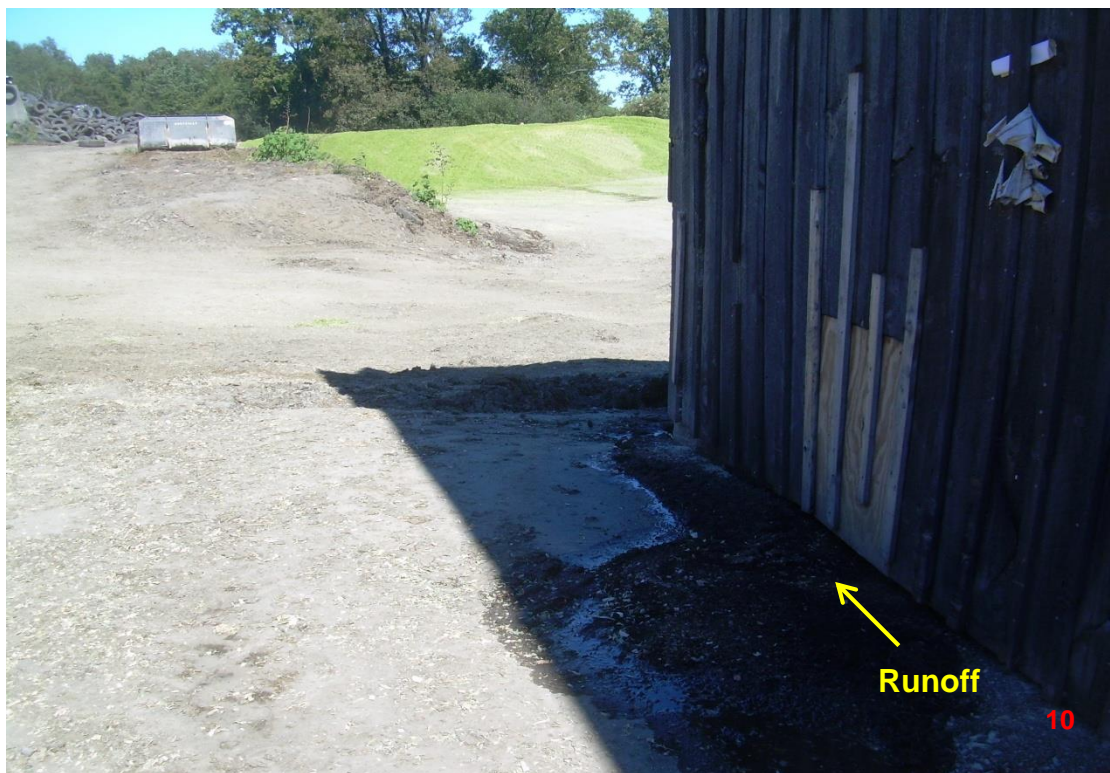
Picture 10 – Allendale Farm, 2357 Jersey Street, Pantton, VT – 09/19/13  
Runoff/leachate from small silage pile across from the main barn.

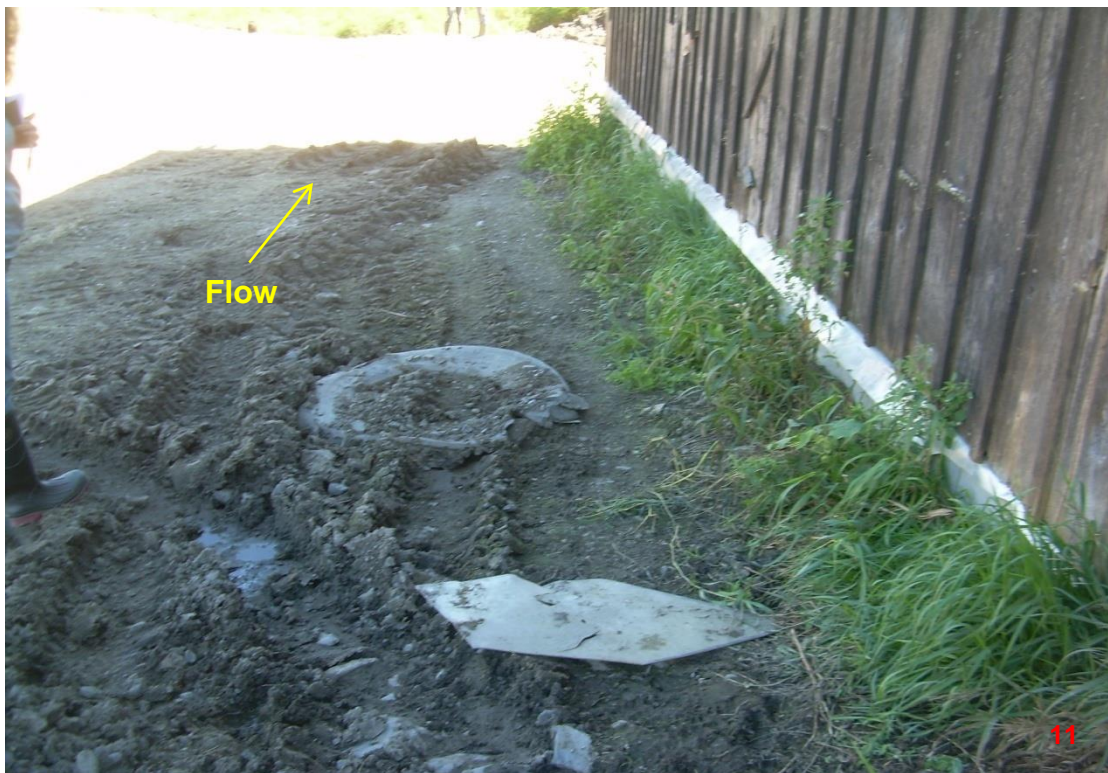
Picture 11 – Allendale Farm, 2357 Jersey Street, Pantton, VT – 09/19/13  
Runoff direction from the small silage pile in pictures # 9-10, (looking east).

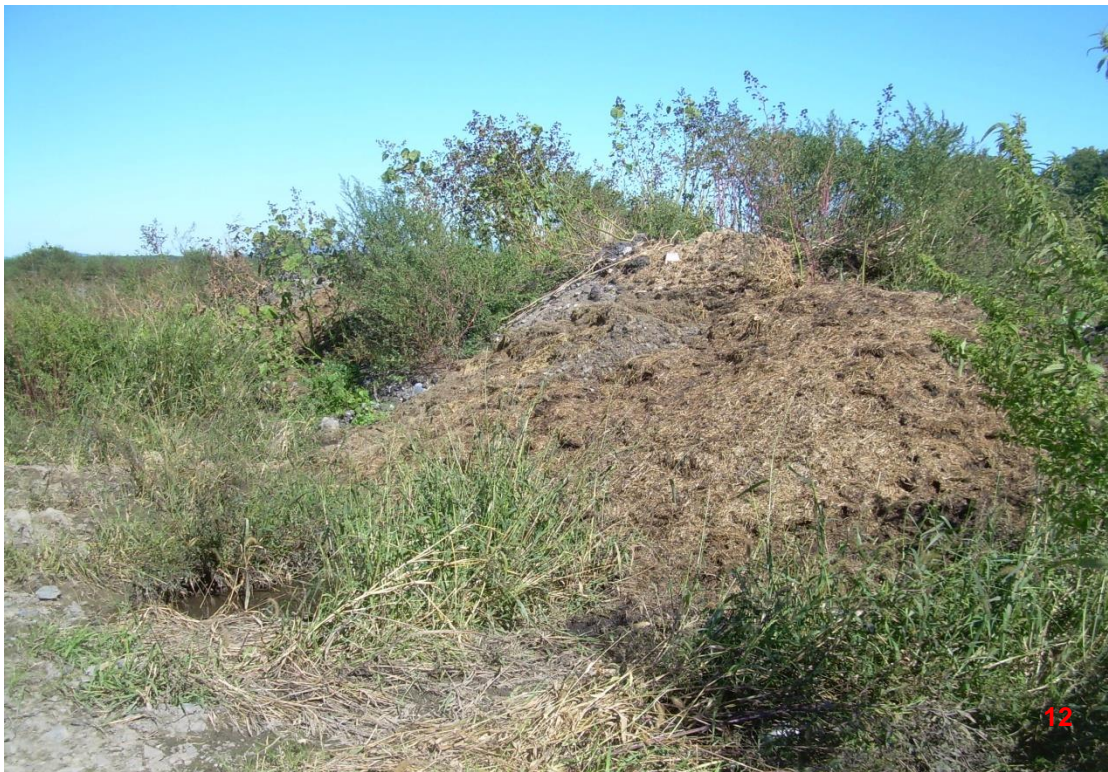
Picture 12 – Allendale Farm, 2357 Jersey Street, Pantton, VT – 09/19/13  
Mortality compost pile, located on the east side of the dirt road at the edge of the field.
